# Manhole Inspection Summary

Manhole # S33II1022MH

**Location** Address: **CHARLES ST**

Cross Street: **STRATFORD RD**

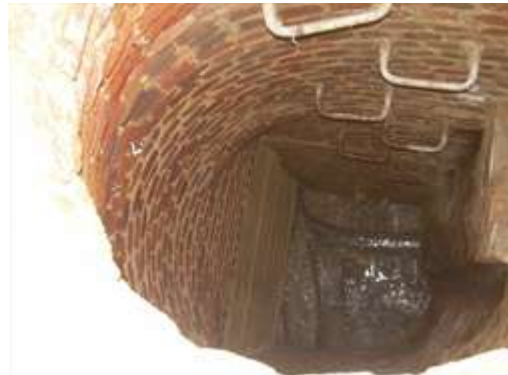
Top View

Corroded steps. Bench debris.

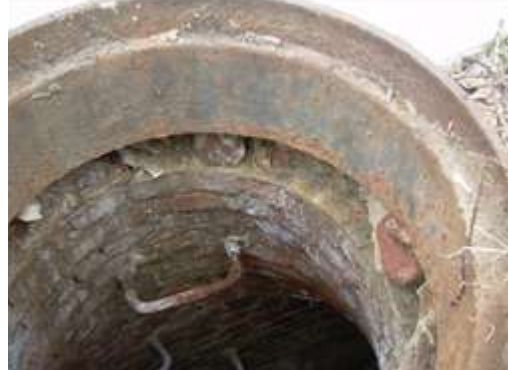
Defect

Condition: ☐ Sound ☒ **Cracked** ☐ Root Intrusion ☒ **Loose Brick** ☐ Deteriorated

Infiltration: ☐ None ☒ **Joint** ☐ Cracks ☐ Mortar ☐ Roots ☒ **Wall**

Frame leaks. Adjustment loose brick, deterioration and infiltration. Corbel infiltration.

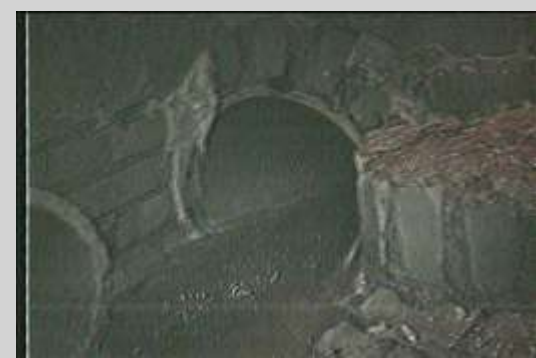
### 12 in. Circular Gravity Sewer Pipe Out @ 12 O'Clock

Infiltration: **None** Pipe Seal Cond: **Unknown**

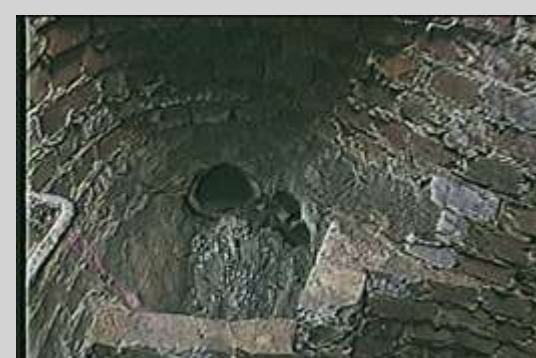
### 6 in. Circular Gravity Sewer Pipe In @ 3 O'Clock

Infiltration: **None** Pipe Seal Cond: **Unknown**

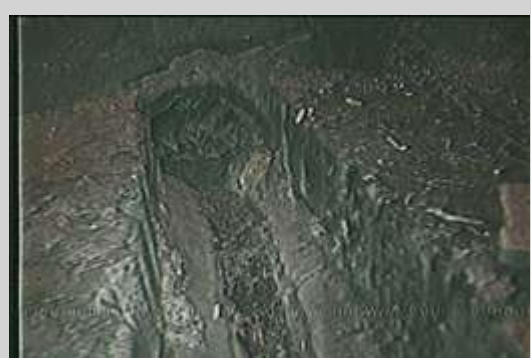
### Drop In @ 3 O'Clock

Drop Condition: **Open**

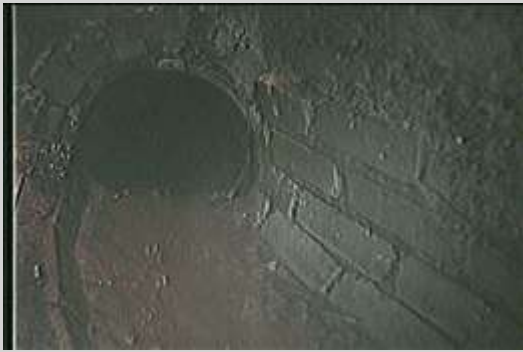
Pipe In @ 6 O'Clock

Infiltration: **None** Pipe Seal Cond: **Unknown**

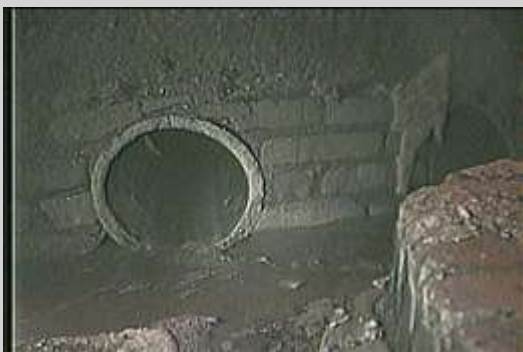
Drop In @ 9 O'Clock

Infiltration: **None** Pipe Seal Cond: **Unknown**
